AV Mediopadana, an Auteur Station?

by Augusto Giuffredi, Enrico Maria Davoli

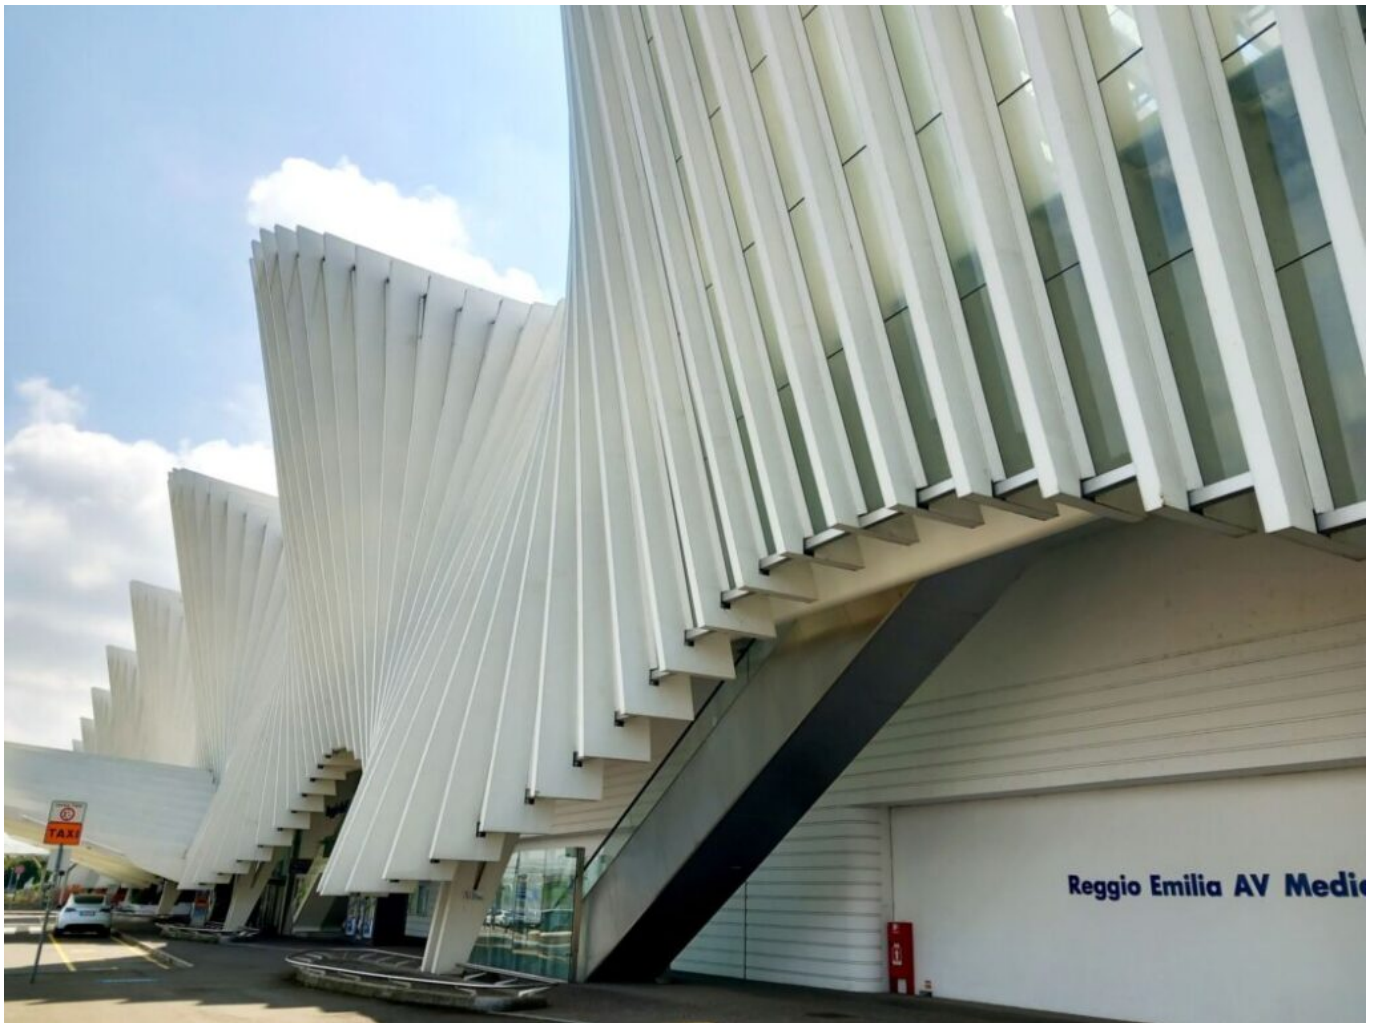
Exterior of the Mediopadana station on the car park side, with in the foreground one of the elevations with anti-slip bollards installed after the inauguration (www.24emilia.com).

At the time of the inauguration, it was noted that the ends of the ribs inscribed at the lowest point of the curvilinear movement ended so close to the ground (about 180 centimetres at the lowest point) that they posed a serious risk to the safety of those entering and leaving the station. In order to avoid the risk of injury to pedestrians' heads, it was necessary to construct elevations surrounded by bollards to prevent pedestrians from passing close to the obstacle.

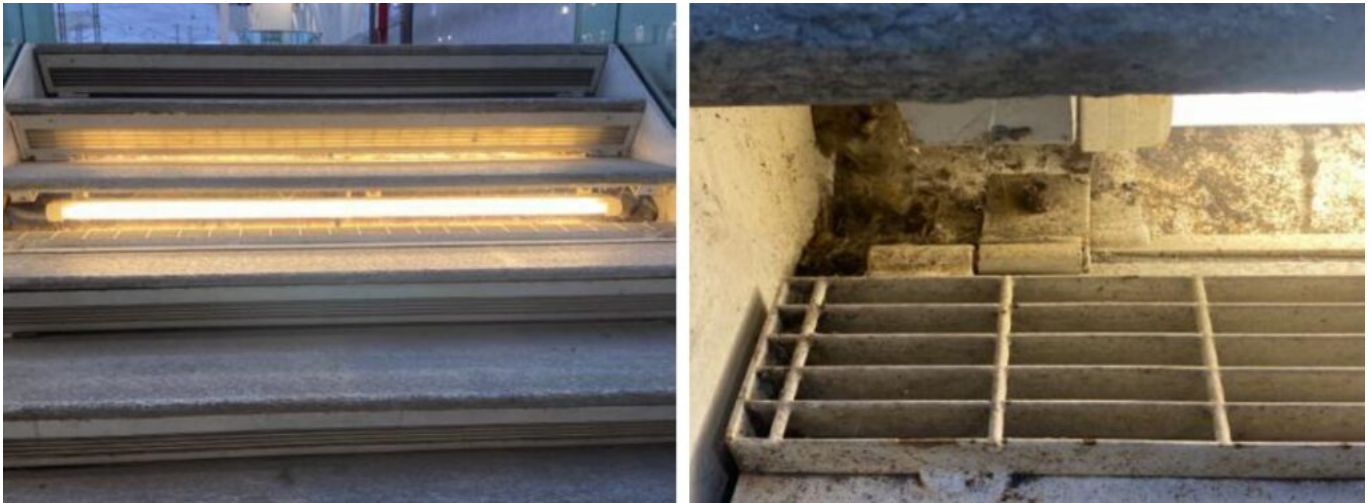
a) Steps of a track access staircase. b) Detail of the riser of a step with an open grid for maintenance (photo credits Augusto Giuffredi).

Access to the tracks is via stairs, escalators and, until recently, a single lift for each of the two departure platforms. The walkable staircase has an illuminated riser protected by a grating: an open system that becomes a receptacle for dust and bacteria of all kinds. The lighting system can only be maintained by unscrewing the metal panels one by one with special Allen wrenches.

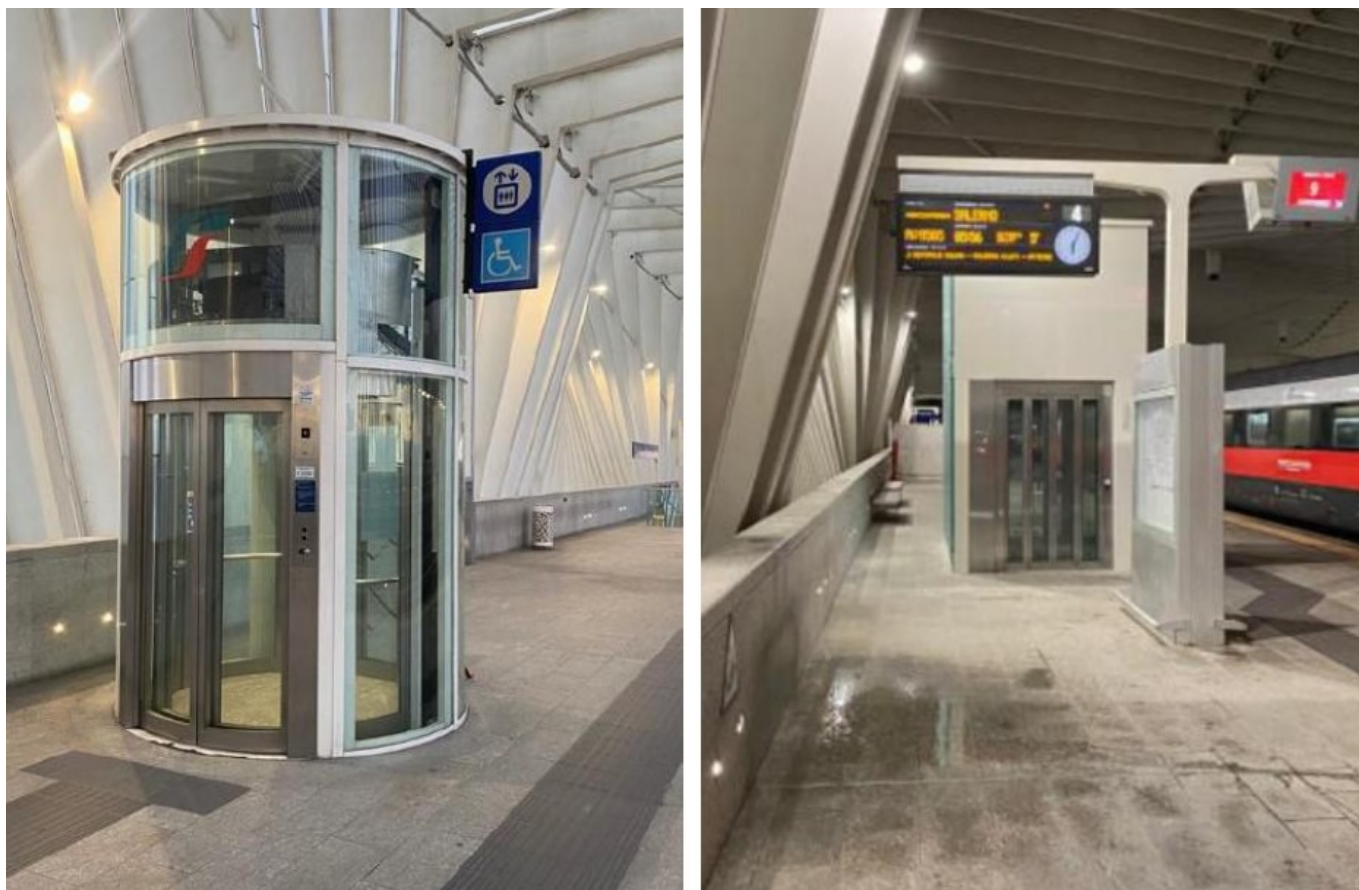
The capacity of the two cylindrical lifts is four people with luggage. The inadequacy of this ascending and descending system was demonstrated during a medical emergency on a moving train. A passenger who had fallen ill was evacuated for emergency medical treatment, which required an ambulance. As the size of the lift did not allow the passage of a stretcher, the medical staff were forced to use the stairs. Two new compliant lifts were subsequently installed for each of the two platforms [2].

a) One of the two lifts currently in operation, b) one of the new compliant lifts, not yet in operation, photographed at track level (photo credits Augusto Giuffredi).

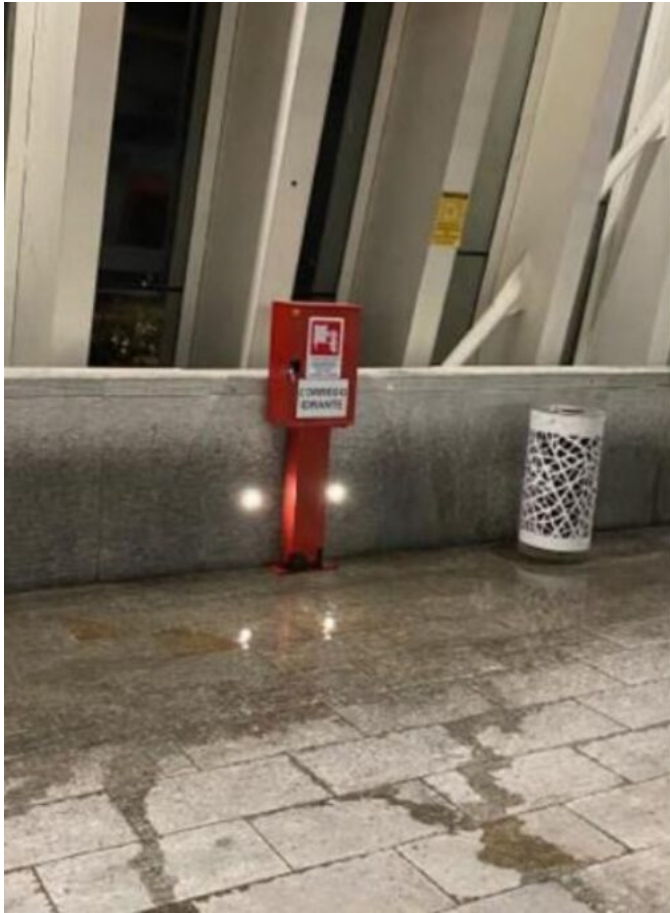
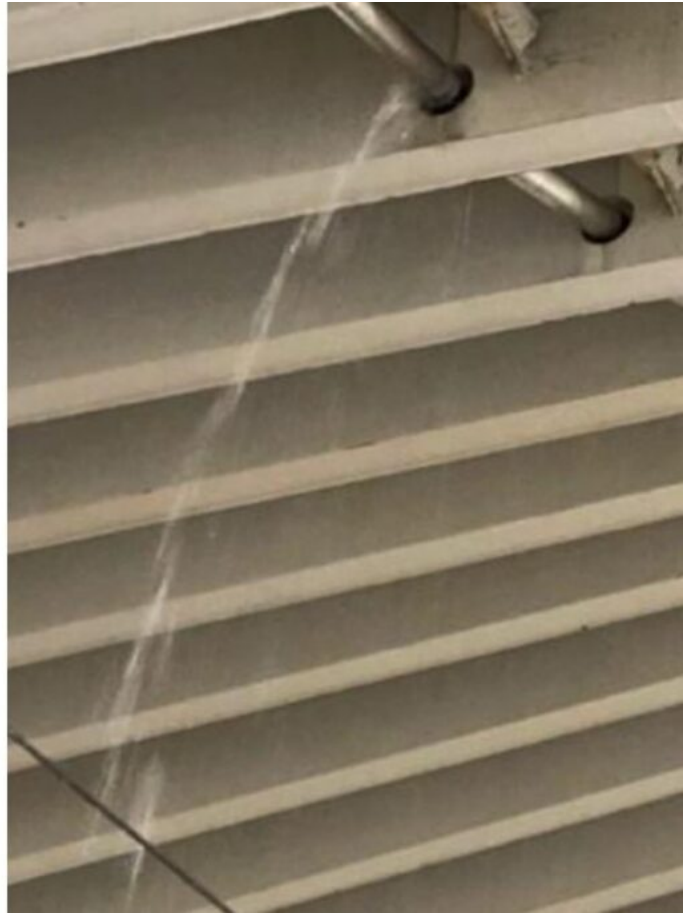
One of the station's most serious problems (along with the bridges mentioned above) is the difficulty of carrying out essential maintenance. On a normal rainy day, the glass roof shows obvious limitations, letting water in at the lowest points. Replacing the glass panes would cost a lot of money and would not solve the problem as the design is flawed. During thunderstorms with rain and wind, water falls on a large part of the platforms, and as the central part of the vault has large openings, the rain driven by the gusts of wind also falls heavily on the waiting passengers.

a) An image of the flooded platform. b) Rainwater leaking from one of the drainage pipes running through the vault (photo credits Augusto Giuffredi).

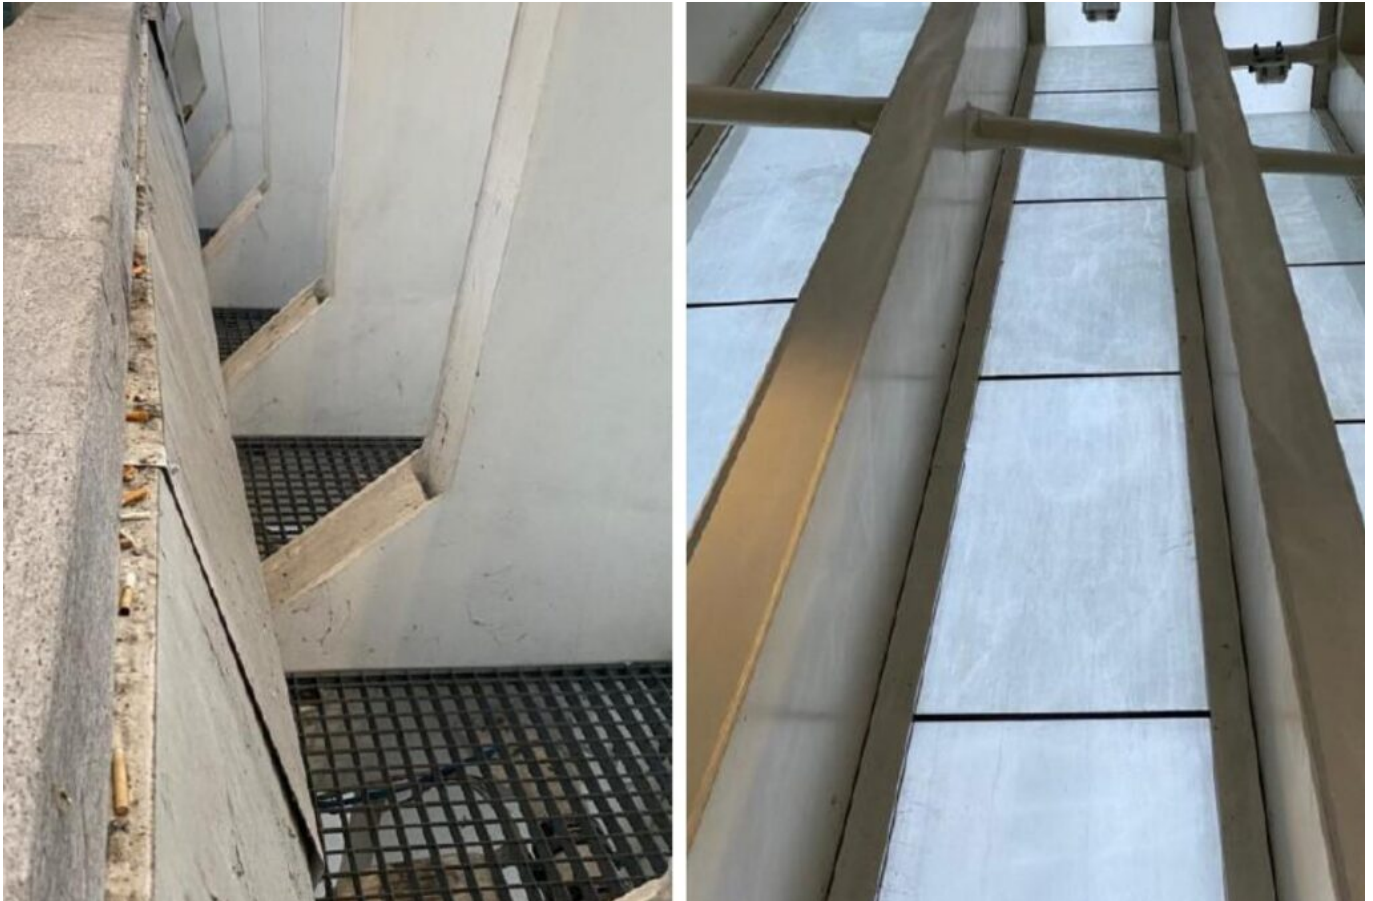
a) Joint between parapet and metal ribs at the height of the boarding sidewalk. b) A section of the ascending glazing with the usual deposit of dust and smog (photo credits Augusto Giuffredi).

Taken together, the various design flaws also undermine the overall aesthetics of the structure. For example, the ill-conceived junction between the pier parapet and the metal ribs causes dust and cigarette butts to accumulate and become virtually impossible to remove. Once again, the glass surfaces pose the greatest problems in terms of cleanliness. The cost of cleaning both inside and out is very high and, given the shape of the building, can only be done using cherry pickers, so the windows are always dirty. This means, among other things, that the effect of transparency, which should be an aesthetic feature of the place, is largely altered.
